Manhole Inspection Summary

Manhole # S25G__032MH

Insp Date: **8/30/07 7:50 AM**

Location Address: **1214 STOCKTON ST**

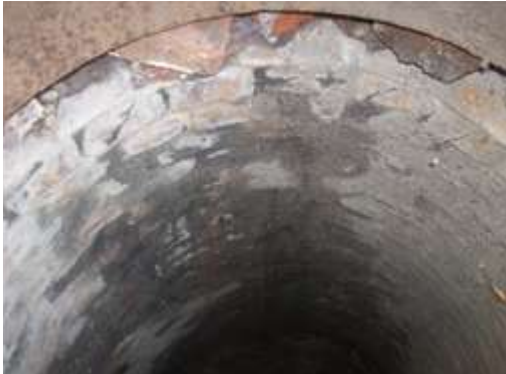
Defect 3

Infiltration: ☐ None ☐ Joint ☐ Cracks ☒ **Mortar** ☐ Roots ☒ **Wall**

INFILTRATION OF THE CORBEL WALL
AND MORTAR

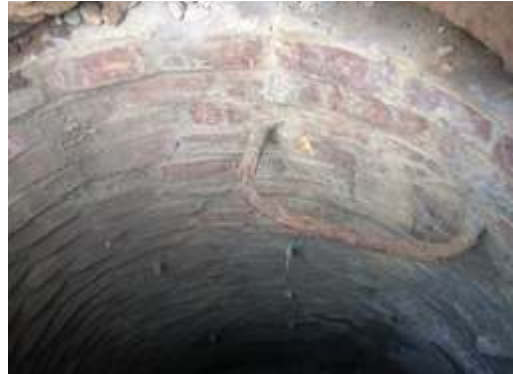
Defect 2

Count: **1** Missing: **4** ☒ **Corroded**

CORRODED AND MISSING STEPS

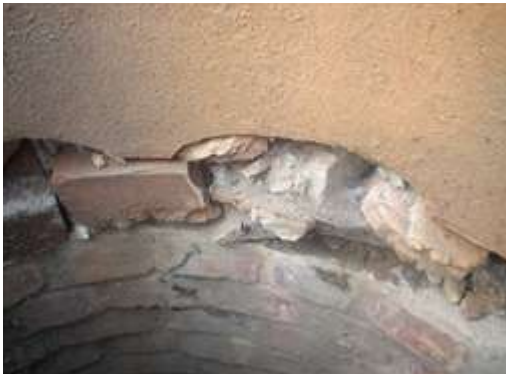
Defect 1

Condition: ☐ Sound ☒ **Cracked** ☐ Leaks

Condition: ☐ Sound ☐ Cracked ☐ Root Intrusion ☐ Loose Brick ☒ **Deteriorated**

DETERIORATED CHIMNEY AND
CHIPPED FRAME

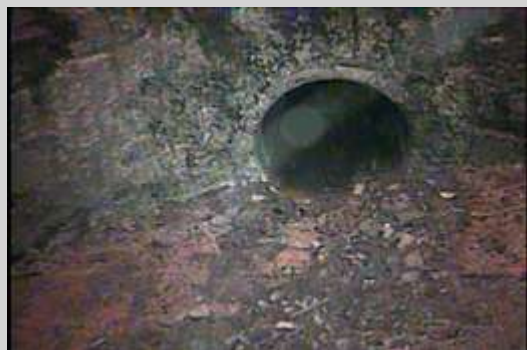
12 O'Clock Outflow

Deposits: ☐ None ☒ **Mud** ☐ Sludge ☐ Debris ☐ Grease

Silt Depth: **1** (in.) Deposits Extent: **Light**
